*Building Review of the West  
Grey Public Library Branches.*

*Ayton, Elmwood, Neustadt and Durham Branches*

October 15, 2014

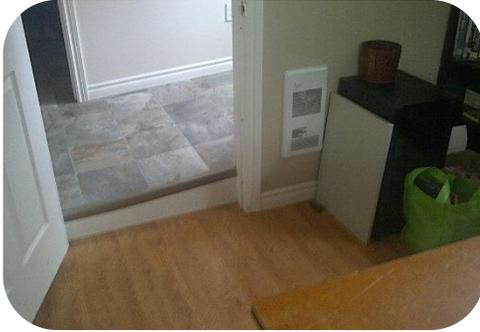
Front room has step down, doesn't meet AODA standards

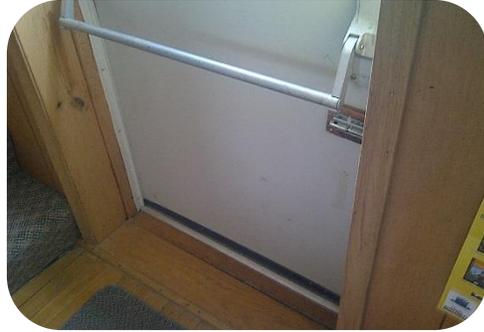
Panic hardware on emergency door

Panic hardware on emergency door - lock needs to be taken off.

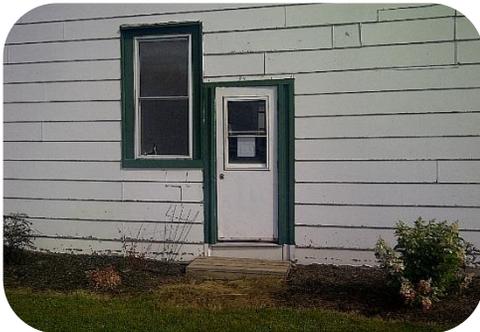
Frame has rotted and settled and caused the inability to open the emergency door

**Recommendation: This building needs a structural and risk assessment done by a third party in order to substantiate the building department recommendations that this building should be demolished.**

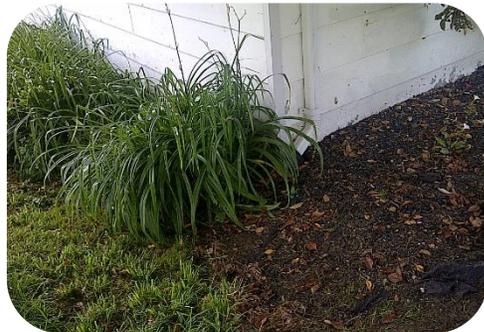
Grading is a huge issue on the south side of the building

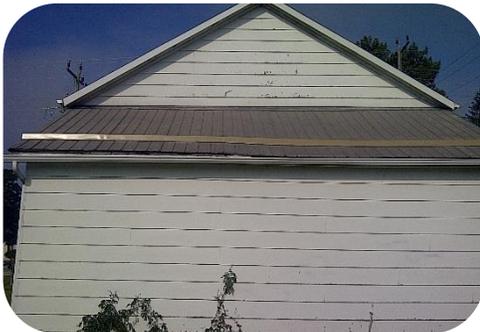
High expectations that all cavity insulation is retaining moisture and creating rot (mold)

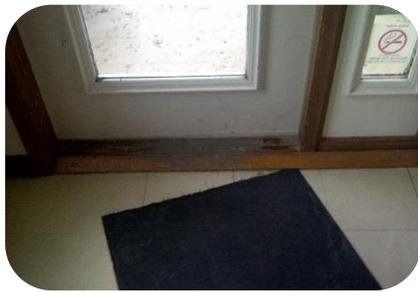
Thresholds - front entrance

Front doors - barrier free operators

Thresholds to be accessible and front doors need barrier free operators

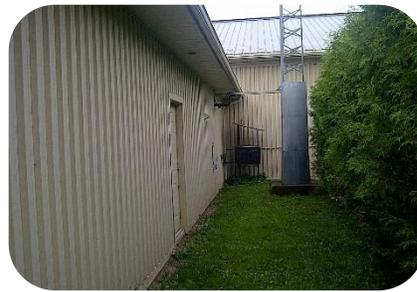
Emergency exit near kitchen needs to be cleared of debris and hard surface pathway to the front of building

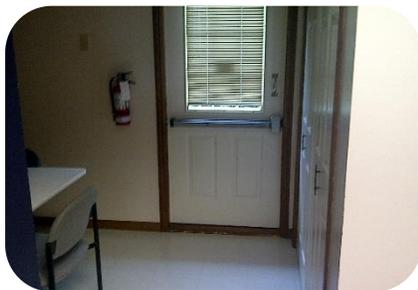
Threshold - emergency exit

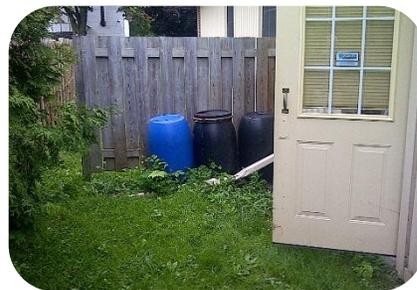
Emergency exit near kitchen needs to be cleared of debris and hard surface pathway to the front of building
